**FAA  
Aviation Safety**

## **SPECIAL AIRWORTHINESS INFORMATION BULLETIN**

**SUBJ:** Wing, Attach Fittings (JASC 5740)

**SAIB:** AIR-21-10

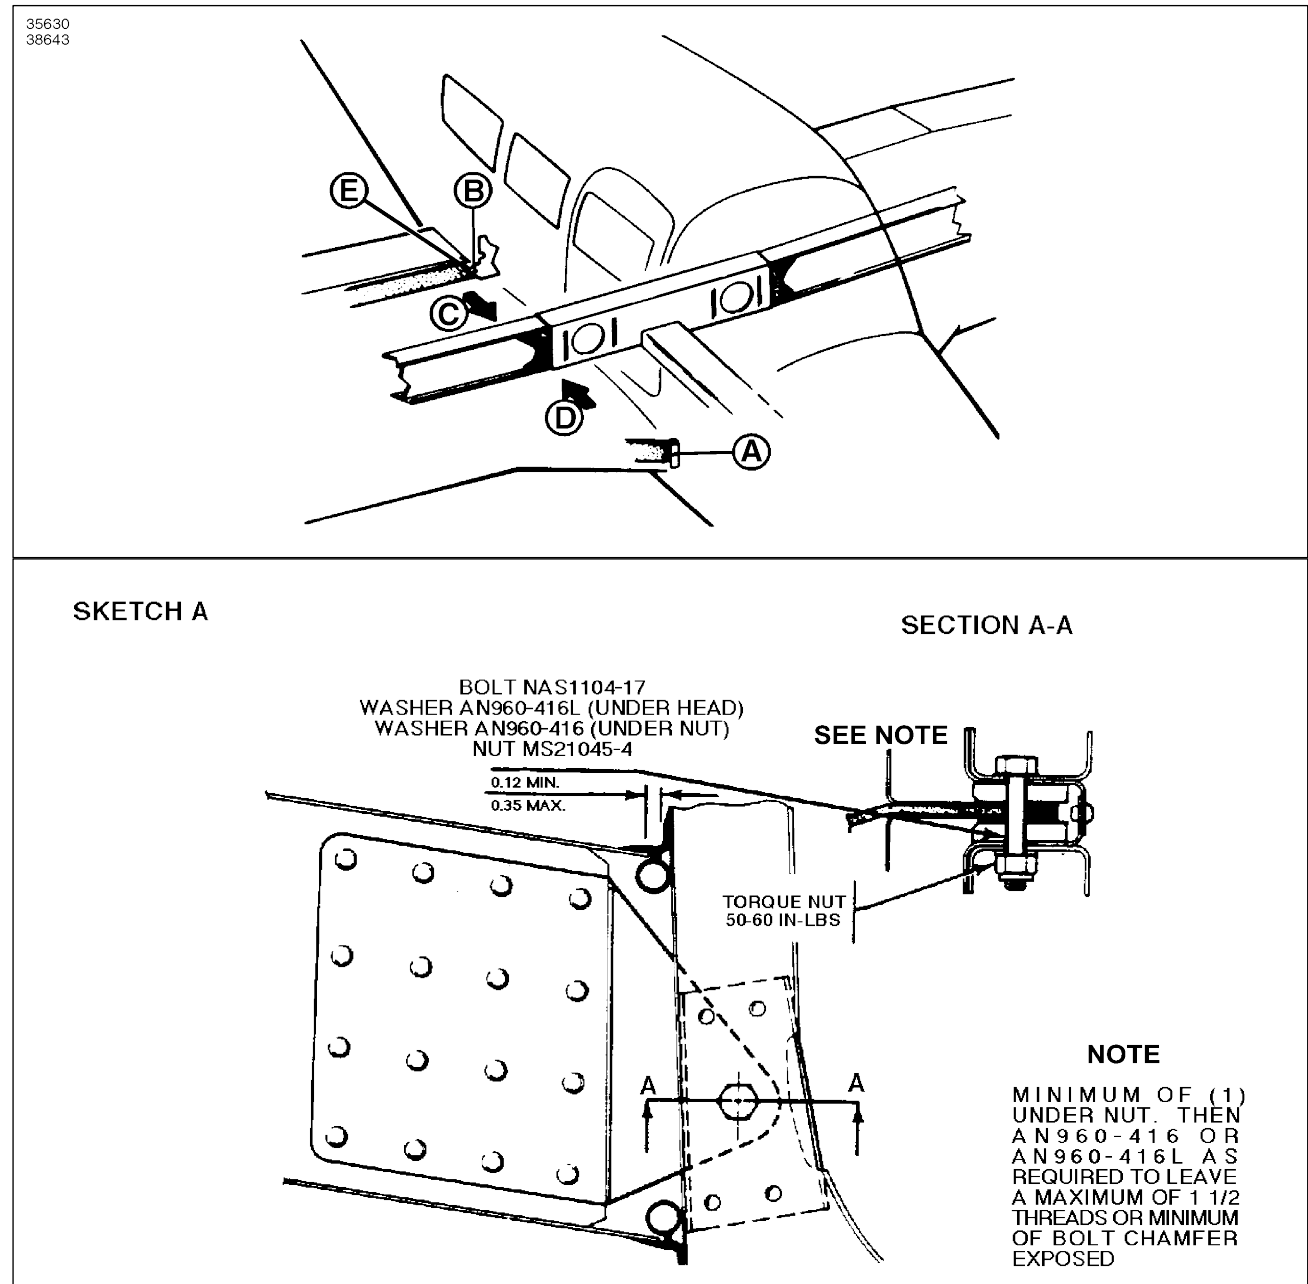
Since then, the FAA became aware of several cases of severe corrosion on the forward attach fittings from operators in Florida. While no evidence exists of water intrusion at the forward locations, the potential exists for galvanic corrosion between the dissimilar metals of the steel fittings and aluminum spar. Due to the restricted accessibility of the forward attach fittings in some airplanes, owners may be neglecting to have this area inspected. See Figures 1 through 3 depicting corrosion location and characteristics.

Figure 1. Forward Attach Fitting

The FAA is recommending that owners take special care to ensure that the forward wing attach fittings are visually inspected during annual or 100-hour inspections in accordance with the applicable Piper Aircraft, Inc. Maintenance Manual. Some operators have had inspection panels or borescope inspection holes installed to facilitate inspection (contact Piper Aircraft, Inc. for acceptable options). "Powdery" rivets in the attach fitting are indicative of corrosion between the

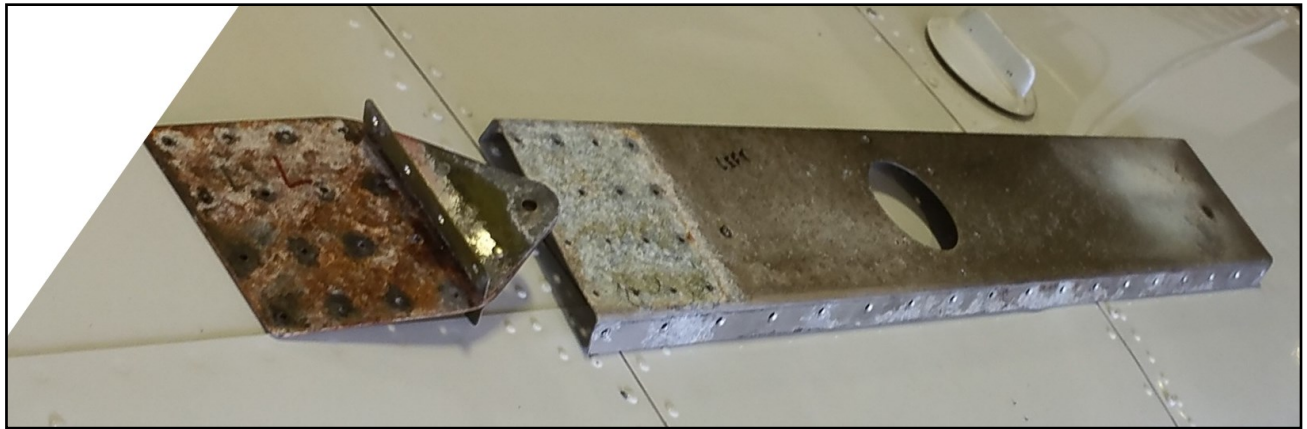
Figure 2. PA-28 Corroded Forward Attach Fitting and Spar Section (removed)

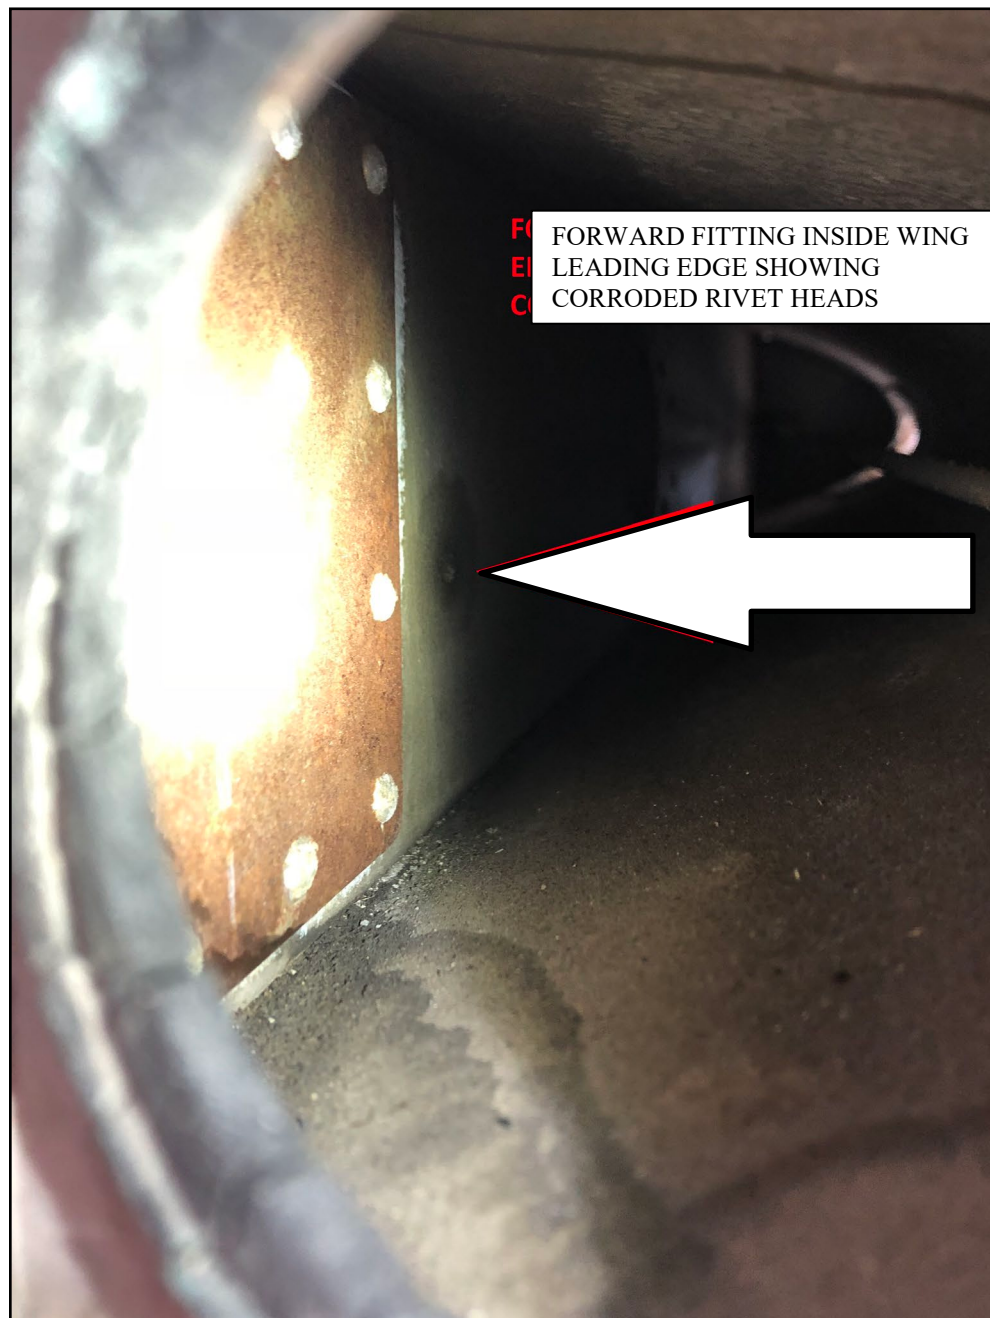
Figure 3. Wing Interior Showing Galvanic Corrosion
