Airworthiness Directive

AD No.: 2016-0026

10-30/24, 12-61/24 R and 12-82/23
Emergency Parachutes

ATA 25 – Equipment / Furnishings – Emergency Parachute Rubber Bands – Replacement

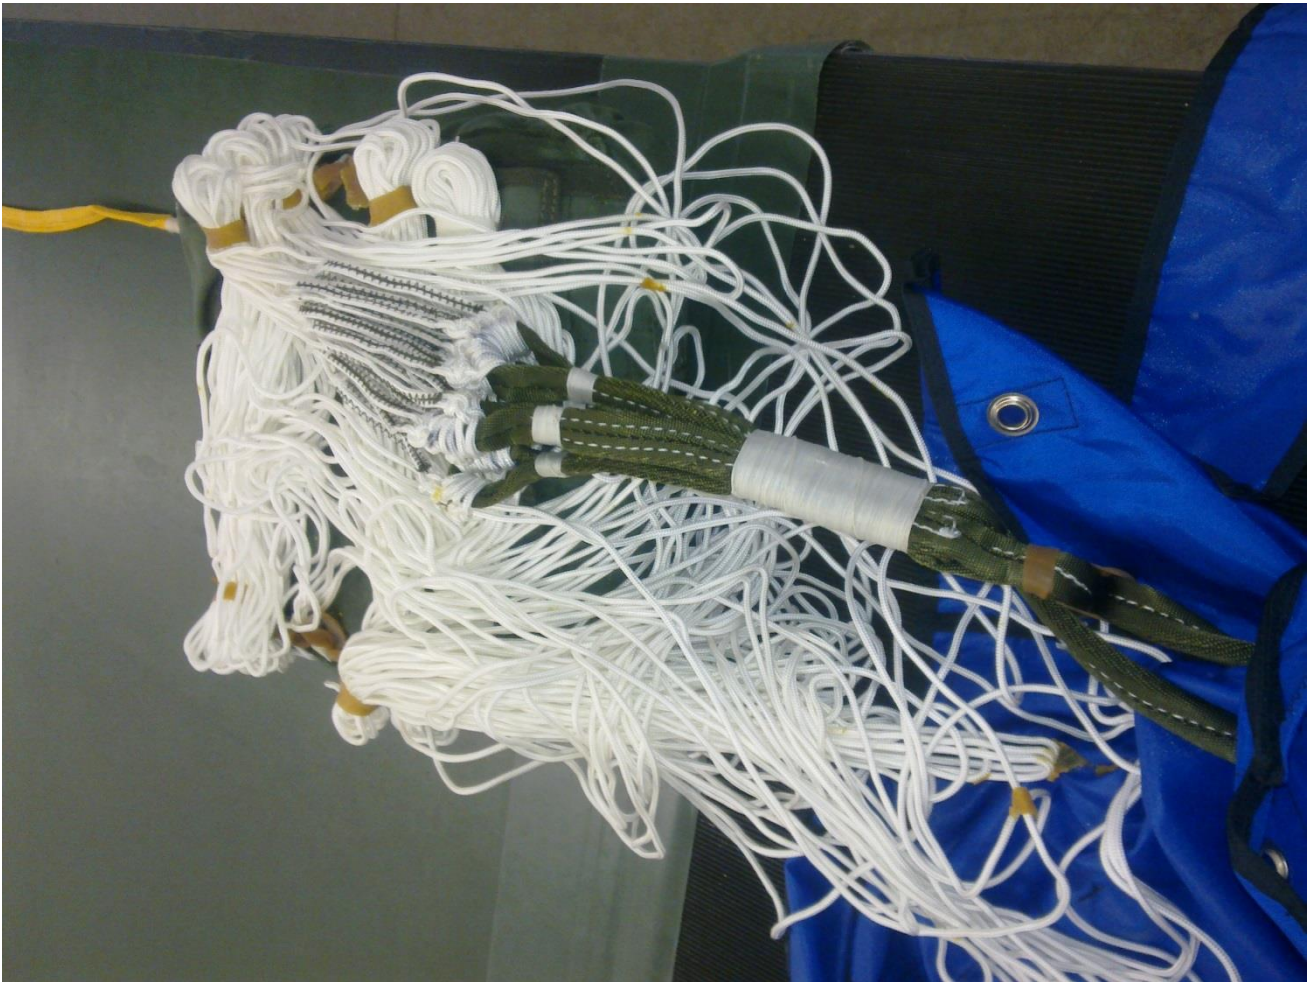
Based on reported occurrences, it has been determined that a batch of rubber bands, used in the production of certain emergency parachutes, has a higher than normal probability to become gummy and sticky, causing the parachute lines to stick to the diaper or bag.

This condition, if not corrected, could cause a malfunction of the emergency parachute. Appendix 1 of this AD contains a picture showing an affected emergency parachute after opening for a scheduled rigging.

- (1) Within 30 days after the effective date of this AD, replace all rubber bands in the emergency parachute with new rubber bands provided by Heinrich Mertens, or new rubber bands of the same size and meeting the specification of MIL-R-1832. Accomplish the replacement in accordance with the instructions of Heinrich Mertens Technische Mitteilung (TM) 002-03-16.
- (2) The replacement of the rubber bands can be accomplished by any person qualified to accomplish the rigging of the parachute. The accomplishment of the replacement has to be recorded by that qualified person on the parachute packing record, which must include a statement on the source and batch identification of the replacement rubber bands.
