## **SPECIAL AIRWORTHINESS INFORMATION BULLETIN**

**SUBJ:** INSTRUMENT PANEL, Potential Installation of Lockwire on Switch Guards that May Restrict Access to Passenger Oxygen and Ram Air Turbine (RAT) Switches

**SAIB:** 2025-09  
**Date:** September 8, 2025

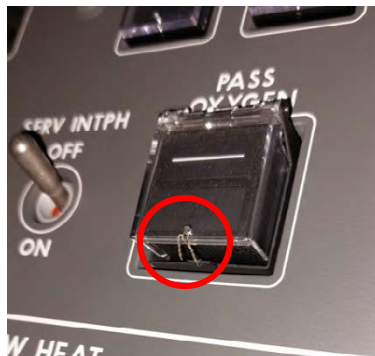
The AMM incorrectly described installing a lockwire instead of a breakaway wire. However, the AMM did identify the correct part number (P/N) MS20995CY15, which is a breakaway wire. (See figure 1 for an illustration of the correct installation of the breakaway wire.) The concern is that maintenance personnel may have installed a lockwire instead of the correct part number because the AMM incorrectly called the wire a lockwire. Accordingly, Boeing revised the AMM in October 2023 to remove the "lockwire" installation steps.

Figure 1 – Example of Breakaway Wire on PASS OXYGEN Switch Guard

- Inspect the passenger oxygen switch guard and RAT switch guard to determine if a breakaway wire or lockwire is installed. If the switch guard does not have a breakaway wire or lockwire installed, no further action is needed.
- To determine if a breakaway wire or lockwire was installed on the switch guard, first pull on the switch guard with one or two fingers to break and remove the wire. If the wire breaks, it is a breakaway wire.
- If the wire does not break, it is a lockwire. Cut and remove the lockwire from the switch guard.
- If it is the operator's policy to use a breakaway wire to prevent inadvertent actuation of a switch, install copper breakaway wire, P/N MS20995CY15 (0.015-inch diameter) on the closed switch guard after determining what type of wire was installed.
